# Debris Management in Sri Lanka

## **Tsunami Reconstruction 7**

### ***Project Report***

December 2007

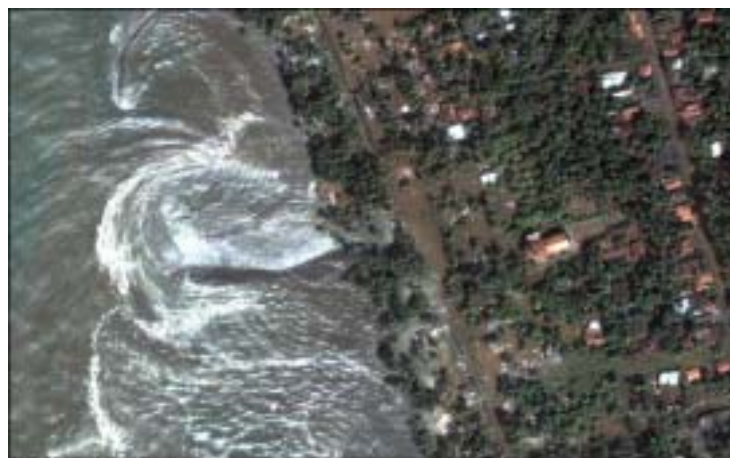
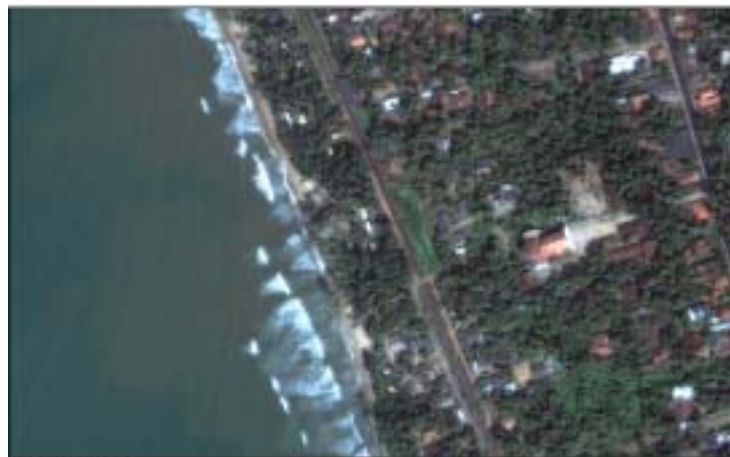
**Photo 1** Extent of damage caused by the Tsunami

December 26, 2004

January 1, 2004

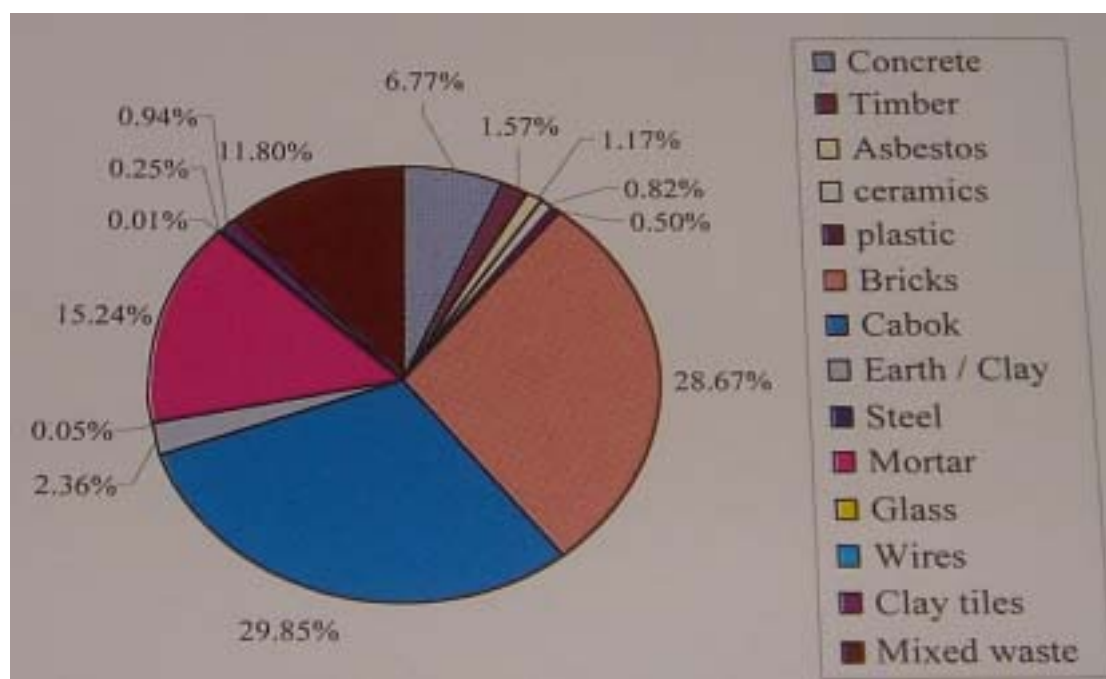
Figure 2 Debris composition in Sri Lanka

Several studies have been conducted to develop statistics on debris in Sri Lanka. When a single story building is demolished it generates 0.34 cubic meters of waste per one square meter. This figure becomes 0.73 m<sup>3</sup>/m<sup>2</sup> for a 2 stored building.

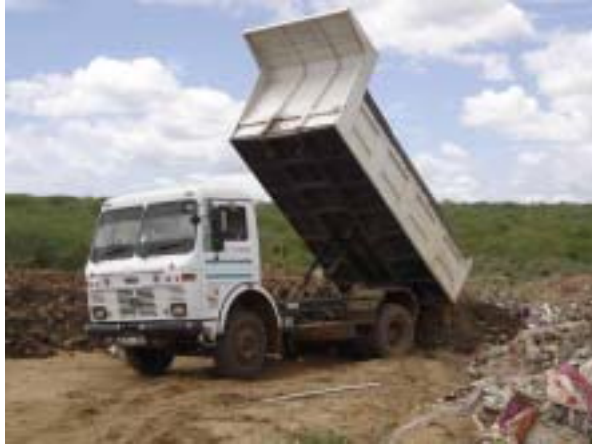
**Photo 2 Dumping debris-Hambantota (Energy Forum)**

- ◆ Dumping (see Photo 2 and Photo 3), in a low lying area for landfilling, with or without soil cover on top;
- ◆ Landfilling in household yards;
- ◆ Using debris to rebuild roads (see Photo 4 and onwards).

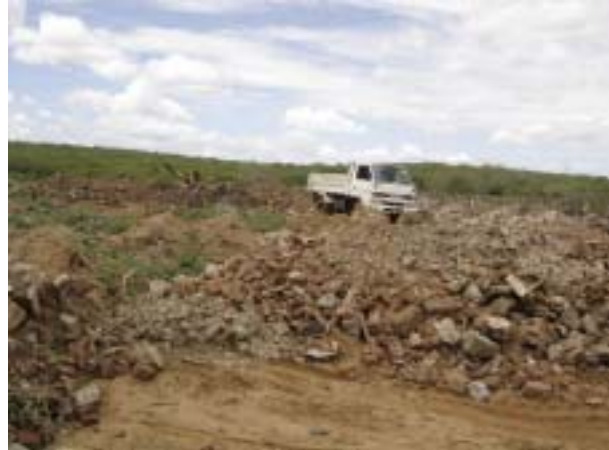
**Photo 3 Debris site – Hambantota (Energy Forum)**

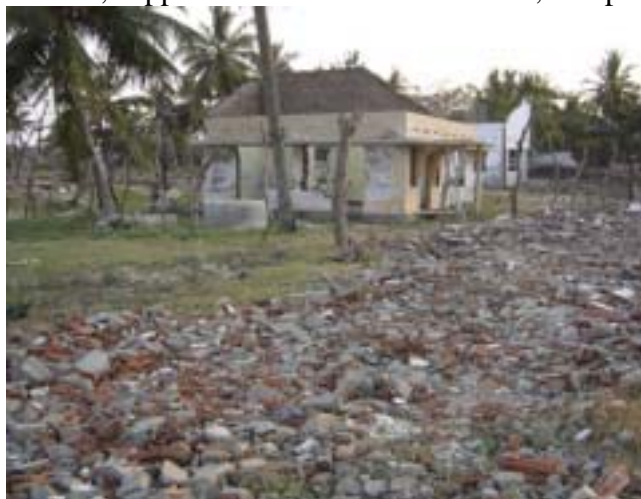
**Photo 4 Road under construction with debris (Energy Forum)**

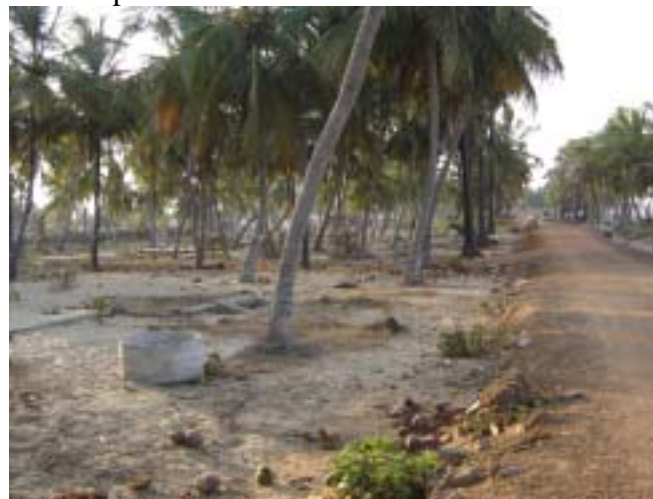
**Photo 5 Road constructed by using debris in Kalmunai (Energy Forum)**

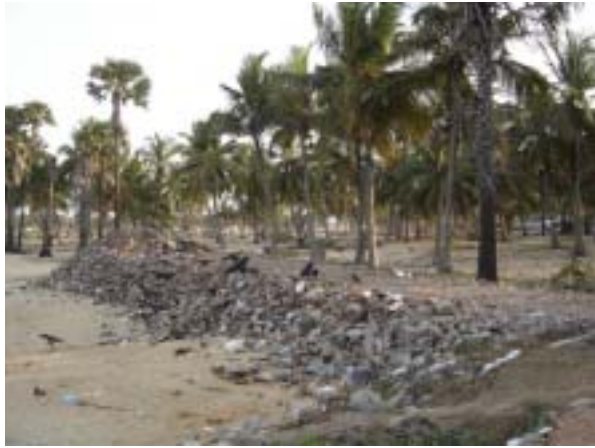
**Photo 6 Road construction-Kalmunai (Energy Forum)**

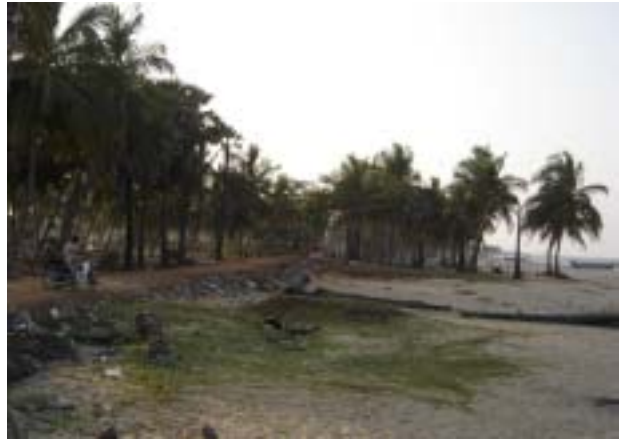
**Photo 7 Constructed road in use-Kalmunai (Energy Forum)**

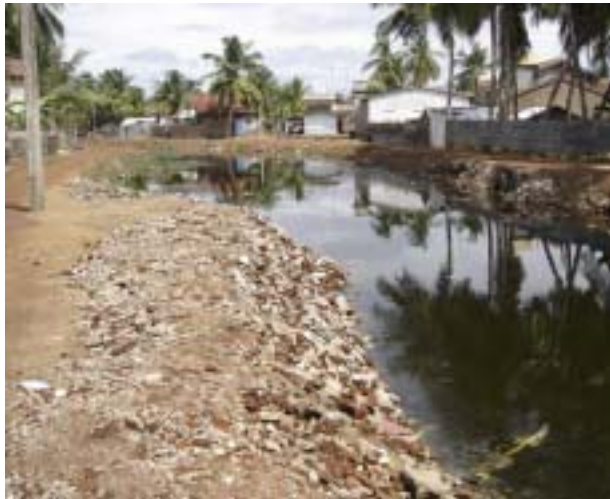
**Photo 8 Constructed road in use-Kalmunai (Energy Forum)**
